## 84030 Rebuild Project

### Newsletter No11 July 2025

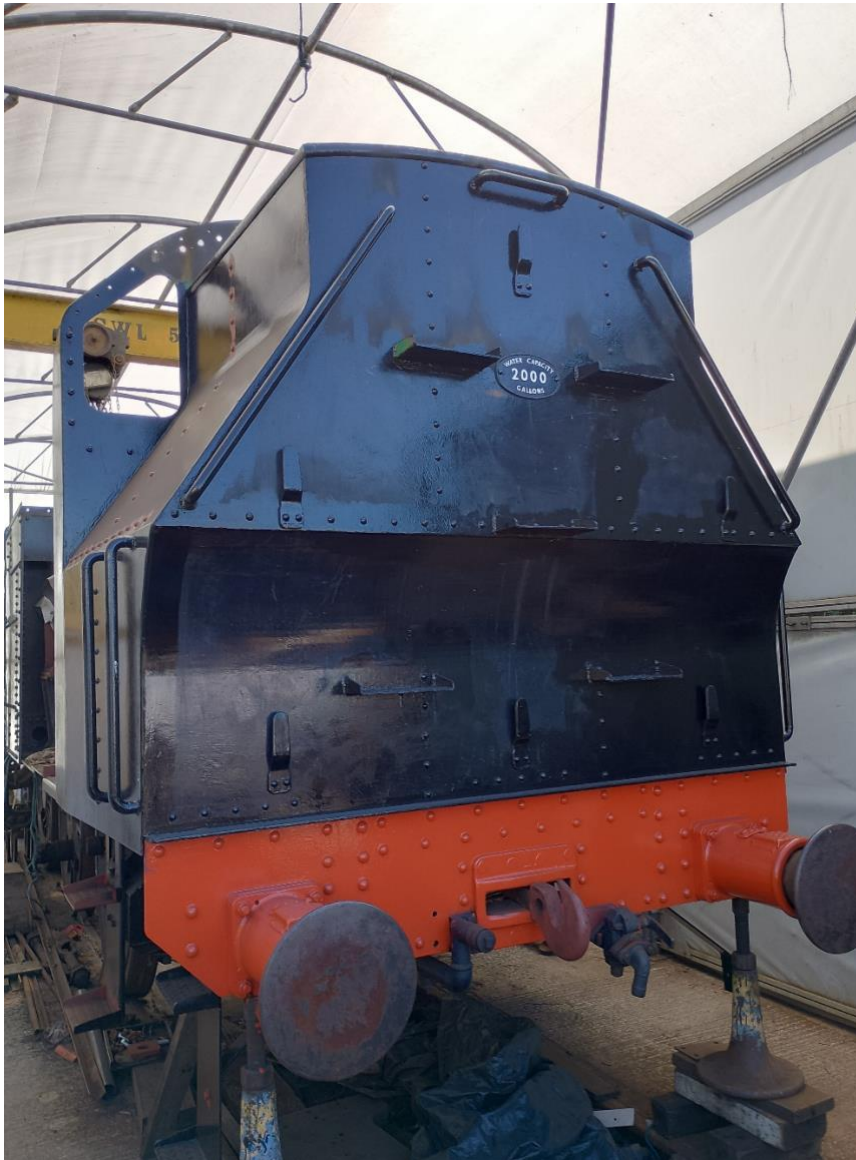
*Bunker with all lamp brackets and steps plus a coat of paint to the bunker back panel and buffer beam*

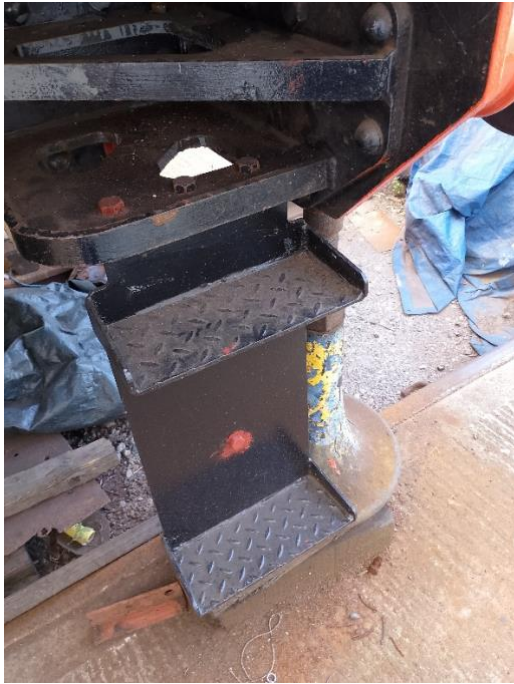
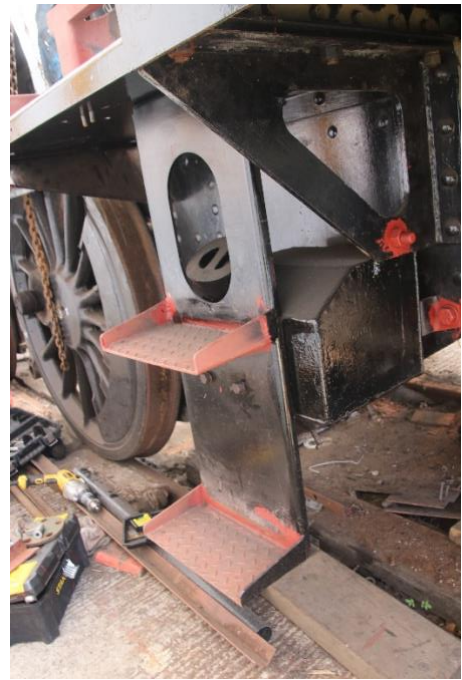
Bunker and Cab steps in their final position

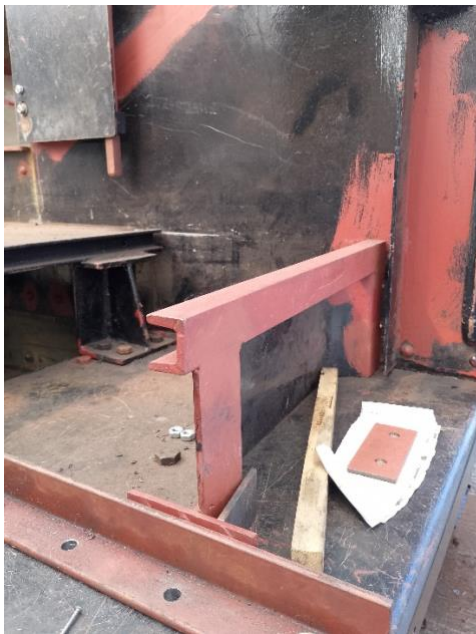
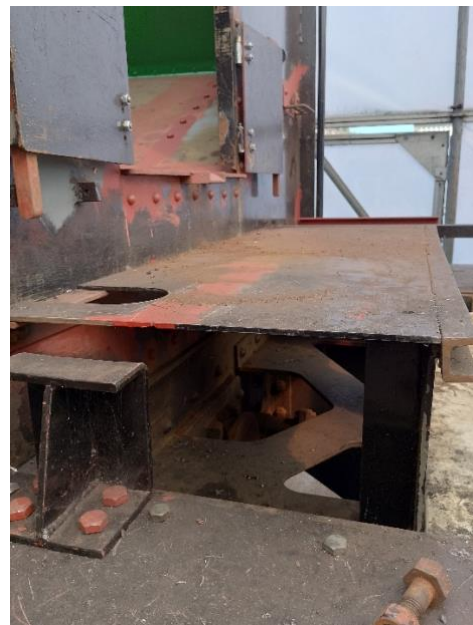
Cab floor supports under construction and shovelling plate in final position

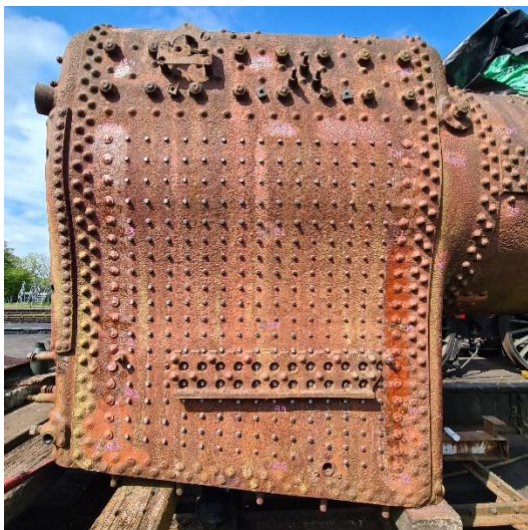
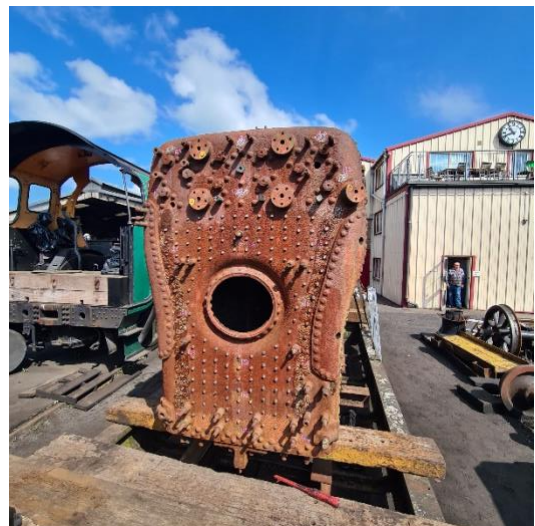
The result was encouraging, the test revealing thinning of the firebox lower outer casing, which was expected, and a known weak spot on the head of the boiler showed some cracks. The cracks were by the side of the strength shoulder plates on each corner of the boiler.

We are advised that neither issue is a major problem and both can be rectified with a new outer plate on the lower section of the firebox and the cracks welded.
